Technical Service Bulletin

TSB10-130-009

APPLIED VEHICLE: 2007 – 2008 GM C/K truck Low or Spongy Pedal after routine brake service

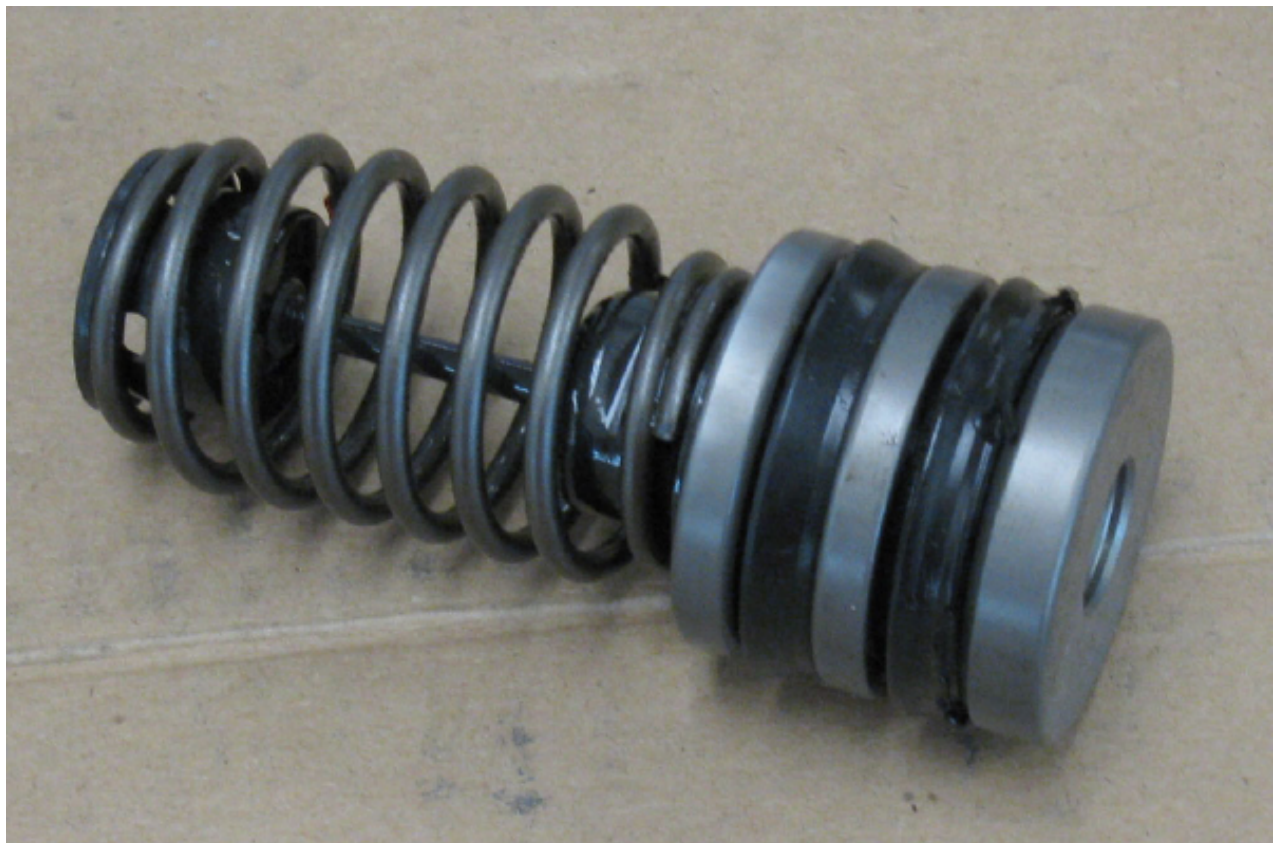
Some vehicles may exhibit a low or spongy pedal after wheel end brake service that cannot be remedied by bleeding the brakes. This may be due to a prematurely deteriorated seal in the master cylinder. Remove snap ring and rearmost piston from master cylinder to inspect seals. If any deformation or deterioration of seals is present, replace the master cylinder.
