Centric Parts
14528 Bonelli St.
Industry, CA 91746
Phone: (626) 961-5775
Fax: (626) 961-5877

Rear Rotor Rubbing on Backing Plate After Installation

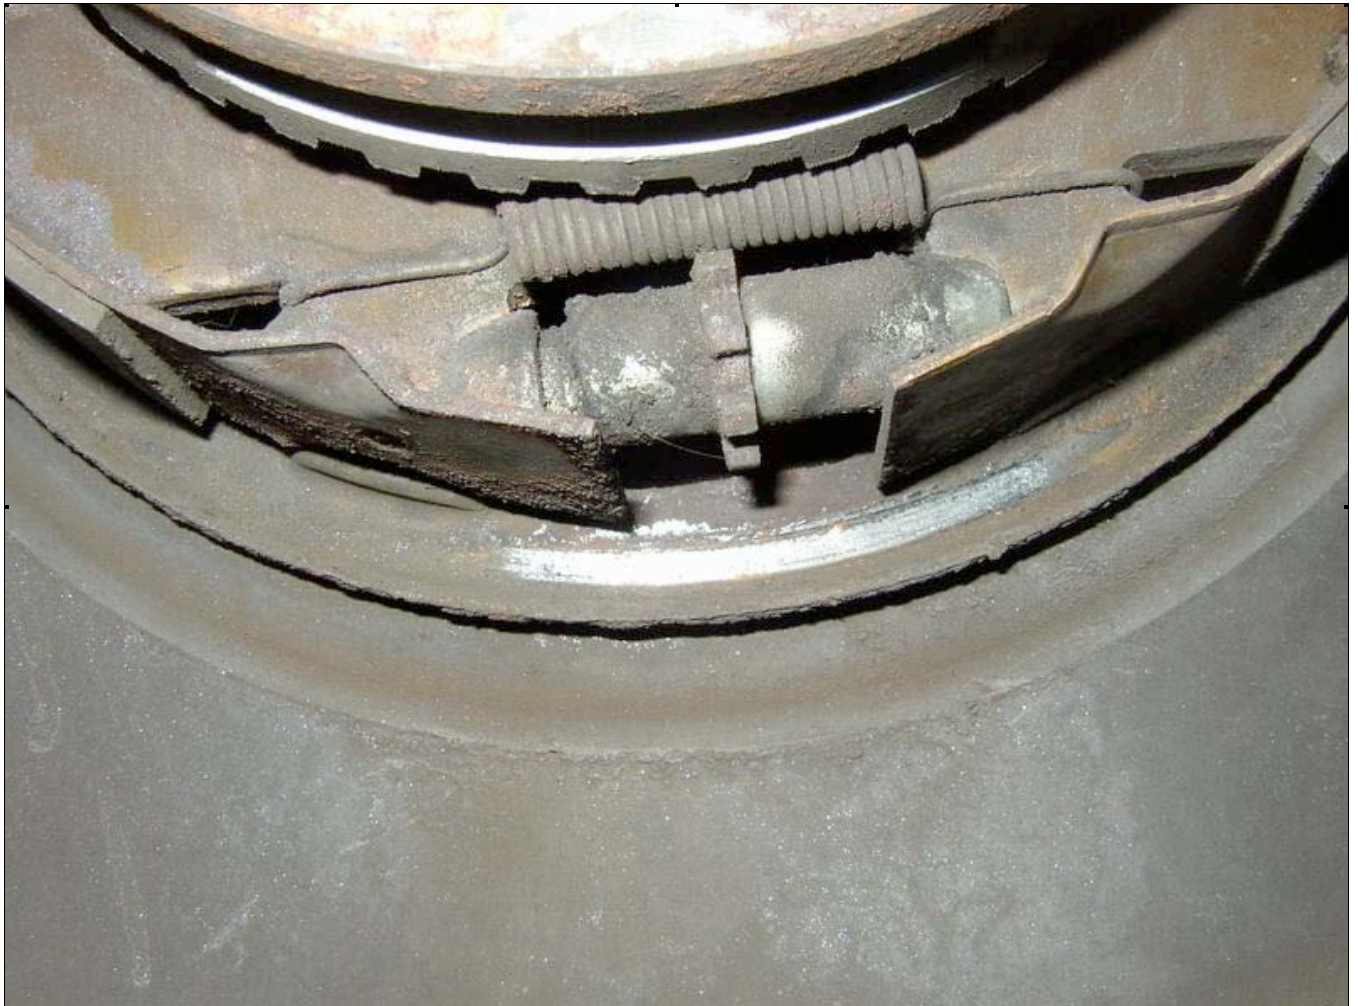
On some Subaru, Honda, and other vehicles utilizing a “Drum-in-Hat” type parking brake system operated in a corrosive environment (road de-icers, salt, etc) the new rear brake rotor may rub against the backing plate. This condition may be caused by corrosion between the backing plate and knuckle assembly that has “jacked” the backing plate away from the knuckle such that it makes contact with the brake rotor. While some may machine/grind the inboard-most edge of the parking brake drum, the correct course of action is to disassemble the parking brake, remove backing plate from knuckle, thoroughly clean all components (replace parts as necessary) and reassemble..
