White Paper:

The Use of Reclaimed Phenolic Pistons in Remanufactured Brake Calipers

By Steve Ruiz, Centric Parts VP of Engineering, Research & Development

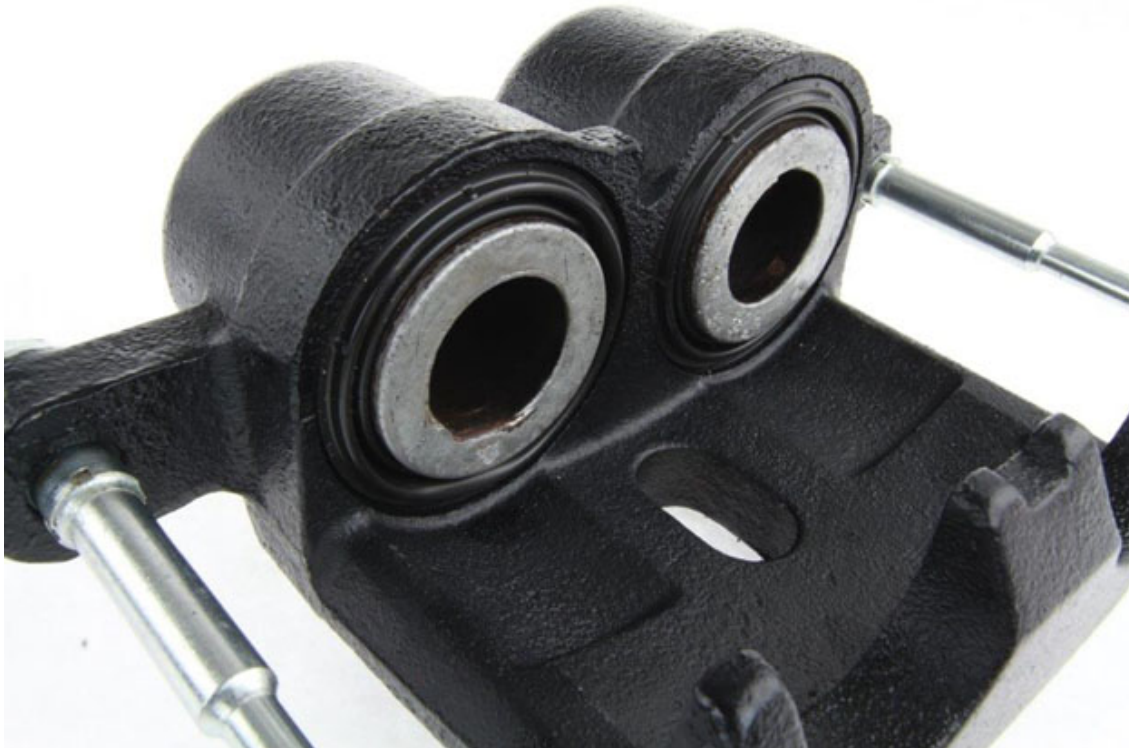
Image 1: Damaged phenolic pistons have been reused in this caliper.

Rebuilt or reclaimed calipers are disassembled, cleaned and rebuilt using new or reused components (image 1).

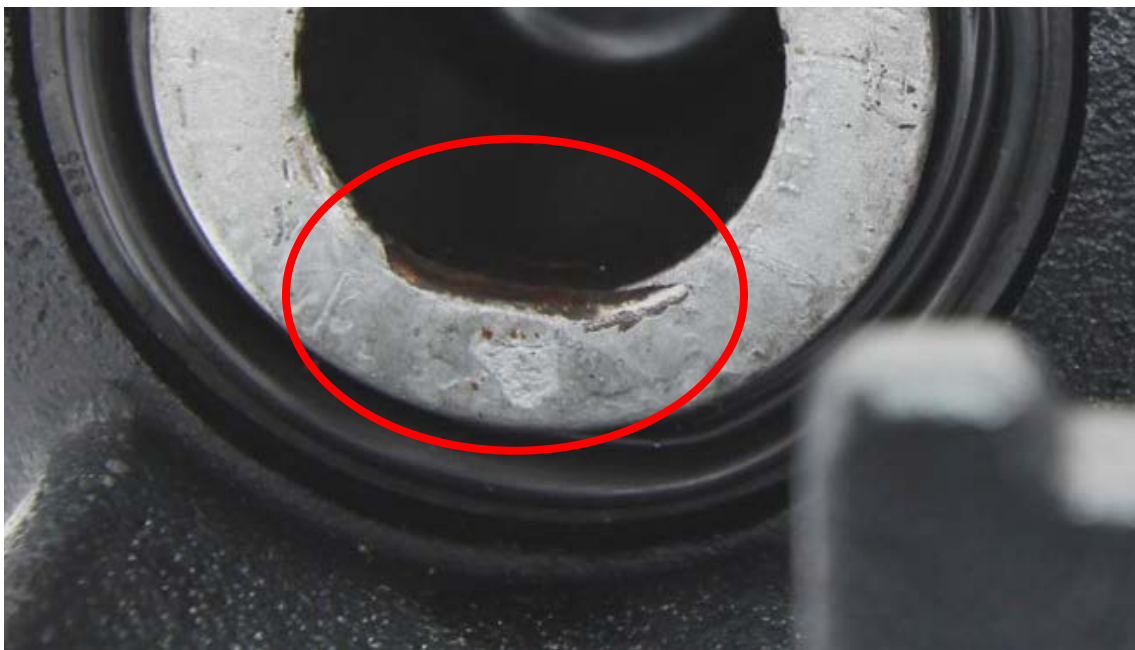
Image 3: Dented and pitted caps; most likely the result of forcing the piston into the caliper with pliers

- It is not uncommon for technicians to force pistons back into the caliper using pliers (Image 3). The result will often be a deformation of the cap that may hide a notched or cracked piston below it.

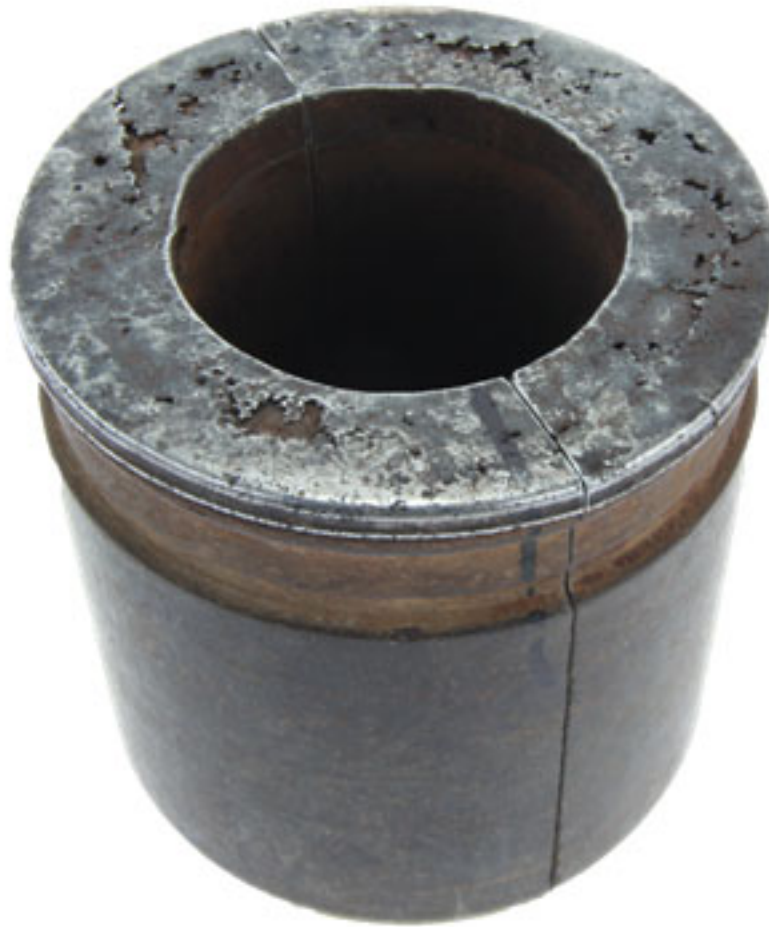
Image 4: Damage to this used piston from an external visual inspection appears to be minimal and contained to the steel cap.

- Material Degradation
 - High Heat Cycles -- Subjected to extended high heat cycles (such as repeated long descents with brakes applied), phenolic material may “over cure” and become brittle, increasing sensitivity to cracking. Visually there would be little to no elongation or distortion prior to failure (images 4 and 5). Failure is not predictable by physical change.

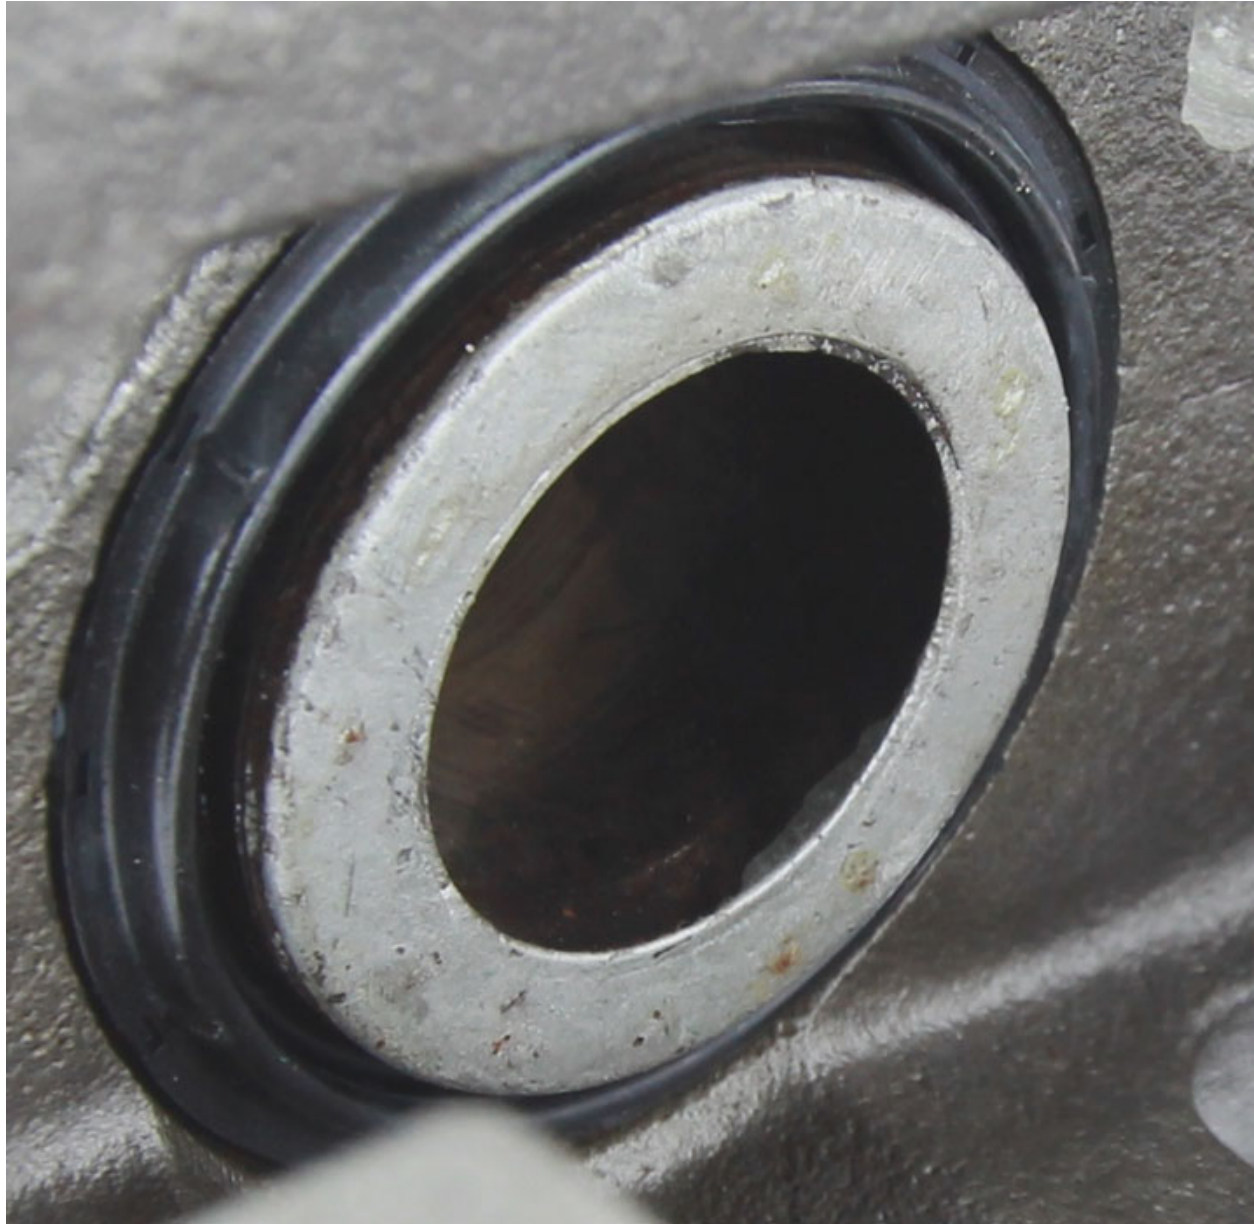
Image 6: Pitted and corroded caps

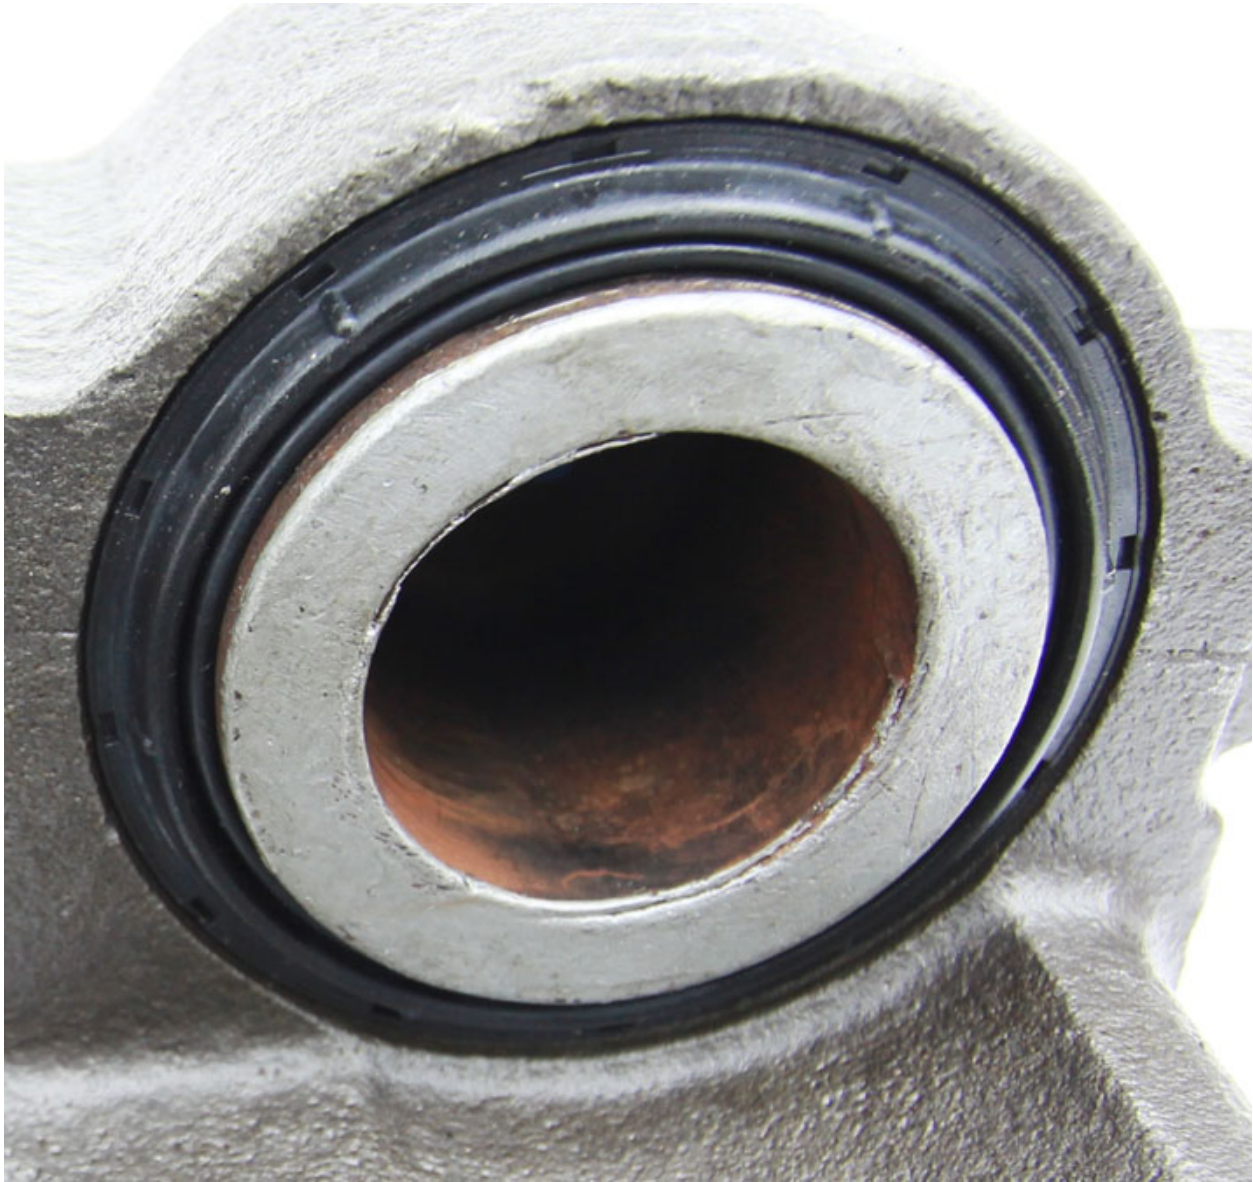
Image 7: Severe corrosion of the cap depositing rust into the piston

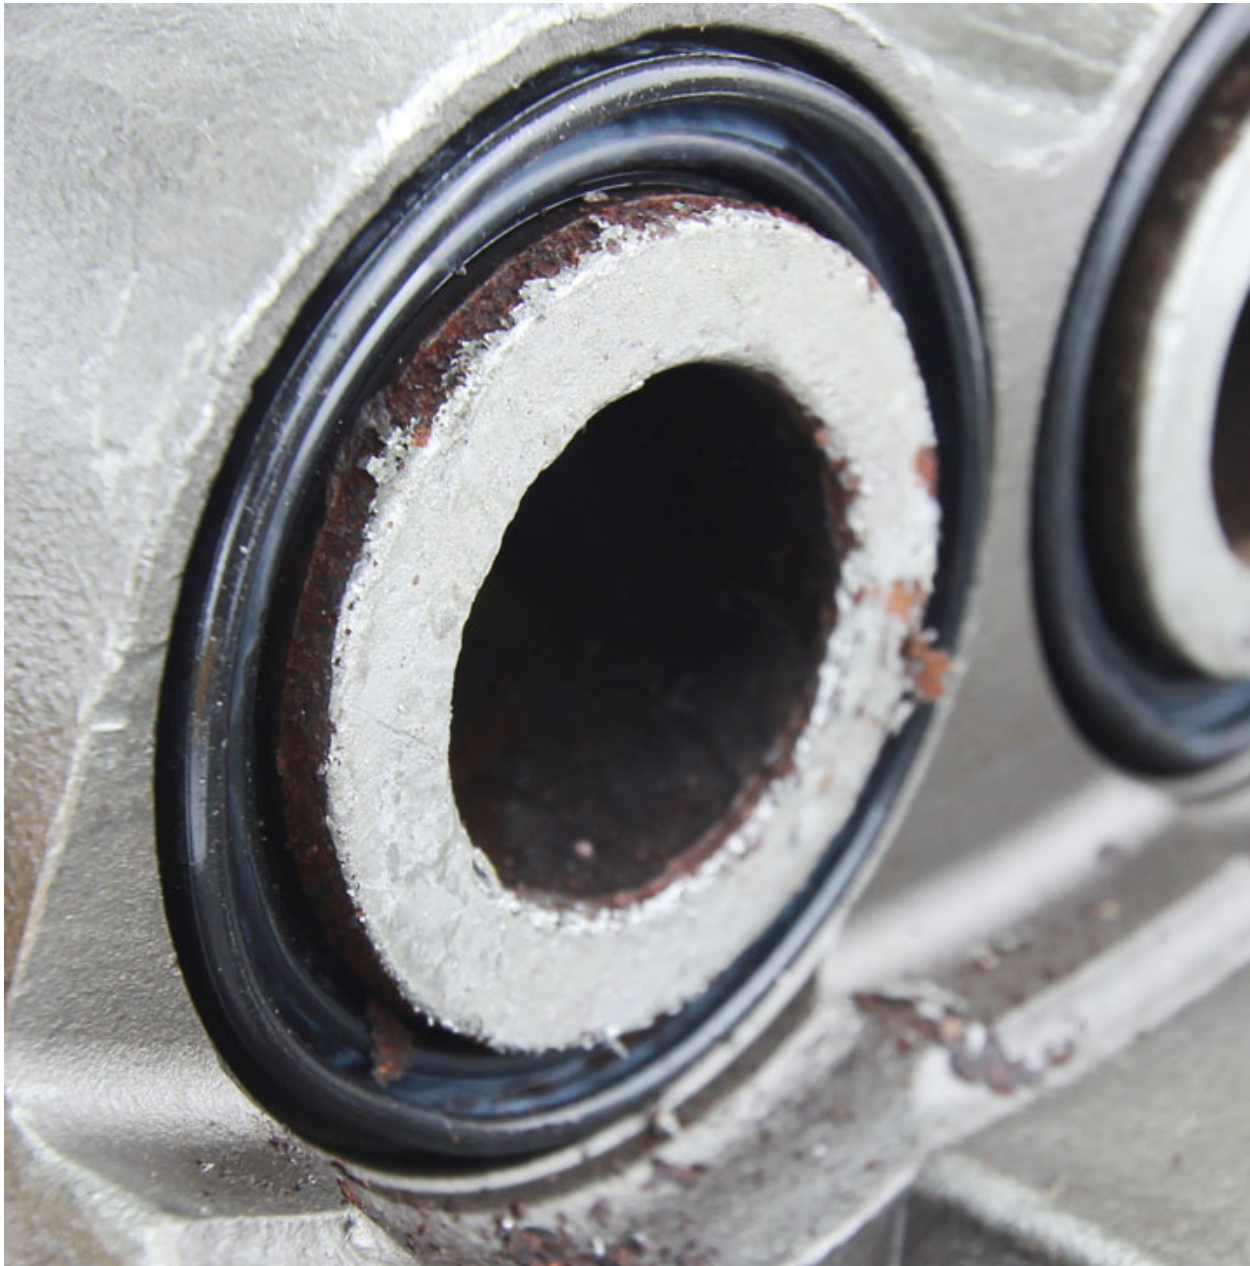
Image 8: Severely corroded cap is flaking apart
